NASA TM -86529

COMPUTED TOMOGRAPHY FOR NON-DESTRUCTIVE EVALUATION OF COMPOSITES: APPLICATIONS AND CORRELATIONS

By B. Goldberg, L. Hediger, and E. Noel

Materials and Processes Laboratory
Science and Engineering Directorate

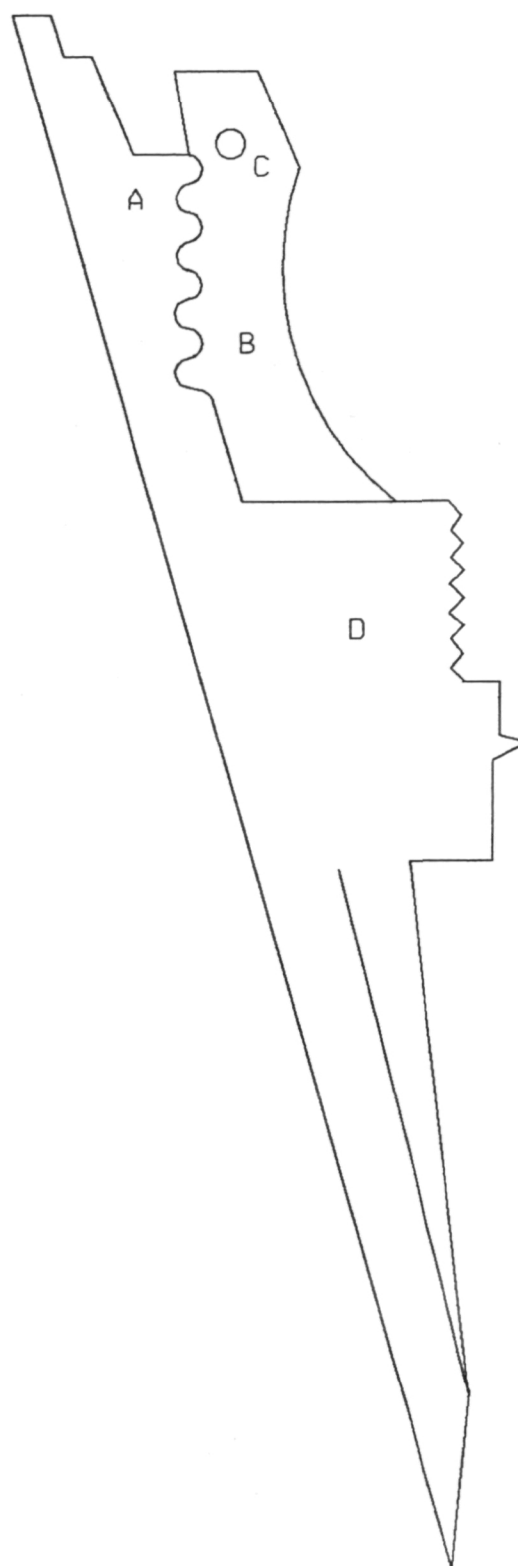
Figure 11. Tangential RT map. [Location guide for CCT-1 correlation effort (A = carbon-carbon exit cone, B = carbon-phenolic, C = o-ring, D = titanium ring).]

The indications from the tangential x-ray data were mapped and their axial locations measured (Fig. 11). These data were then plotted on axial slice maps in an attempt to correlate these data to CT data.

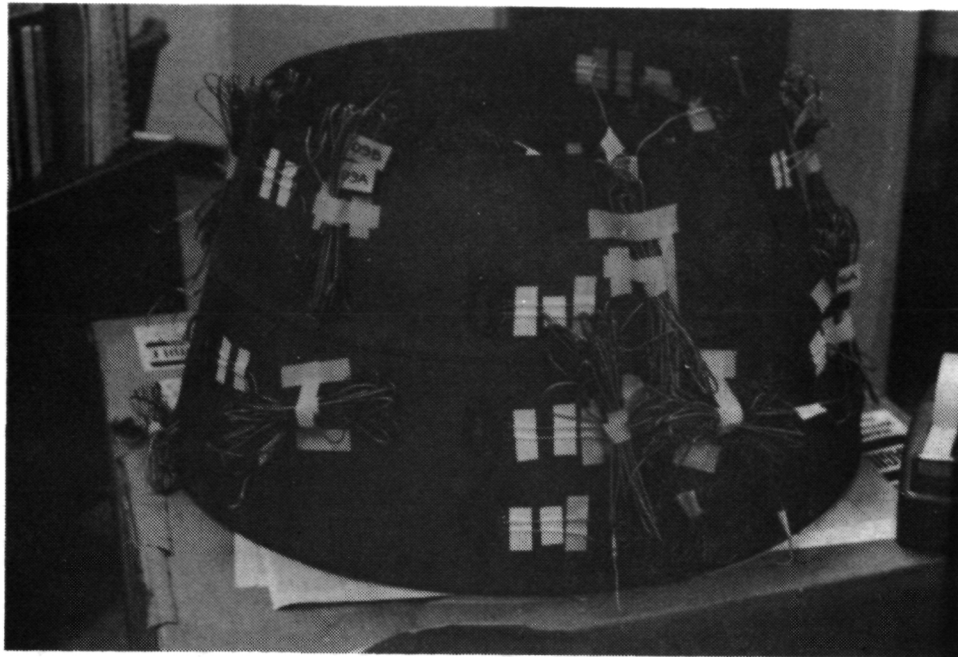
Figure 19. Instrumented cone. (Aft section from CCT-1 instrumented for hydrobuckle test.)

In another attempt to determine the significance of NDE indications, an aft section of the CCT-1 exit cone was examined through x-ray and ultrasonic techniques. The section, 16 in. in axial length, was instrumented with strain gauges and acoustic emission sensors (Fig. 19). The section was then hydrobuckled. A report of this effort has been presented detailing the strain and stress analysis [8].

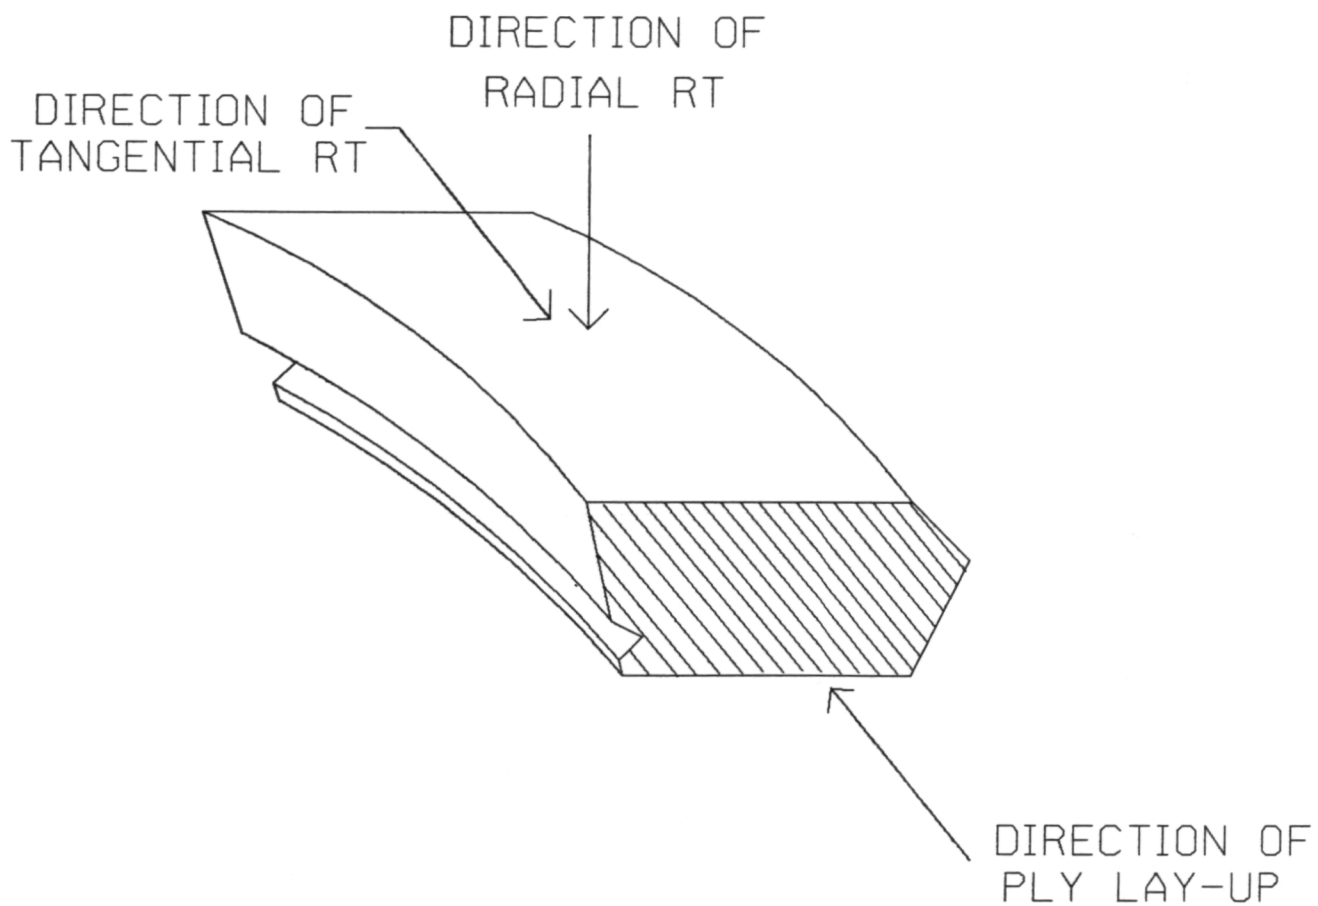
Figure 26. SRM radiographic planes. (To eliminate superpositioning between plys, true tangential RT was applied.)

The initial radiographs of the unfired segments disclosed slight film-density changes which were correlated to visible cloth patterns and cloth-to-cloth lacing patterns in the segments. Several other film patterns were traced to visible surface conditions. Uniform light and dark bands which ran the entire length of the segments were initially attributed to sample geometry effects. Finally, several slight film-density variations were noted. Additional radiographs of the unfired segments, taken in radial and true tangential planes, were examined to investigate these anomalies (Figs. 26, 27, and 28).

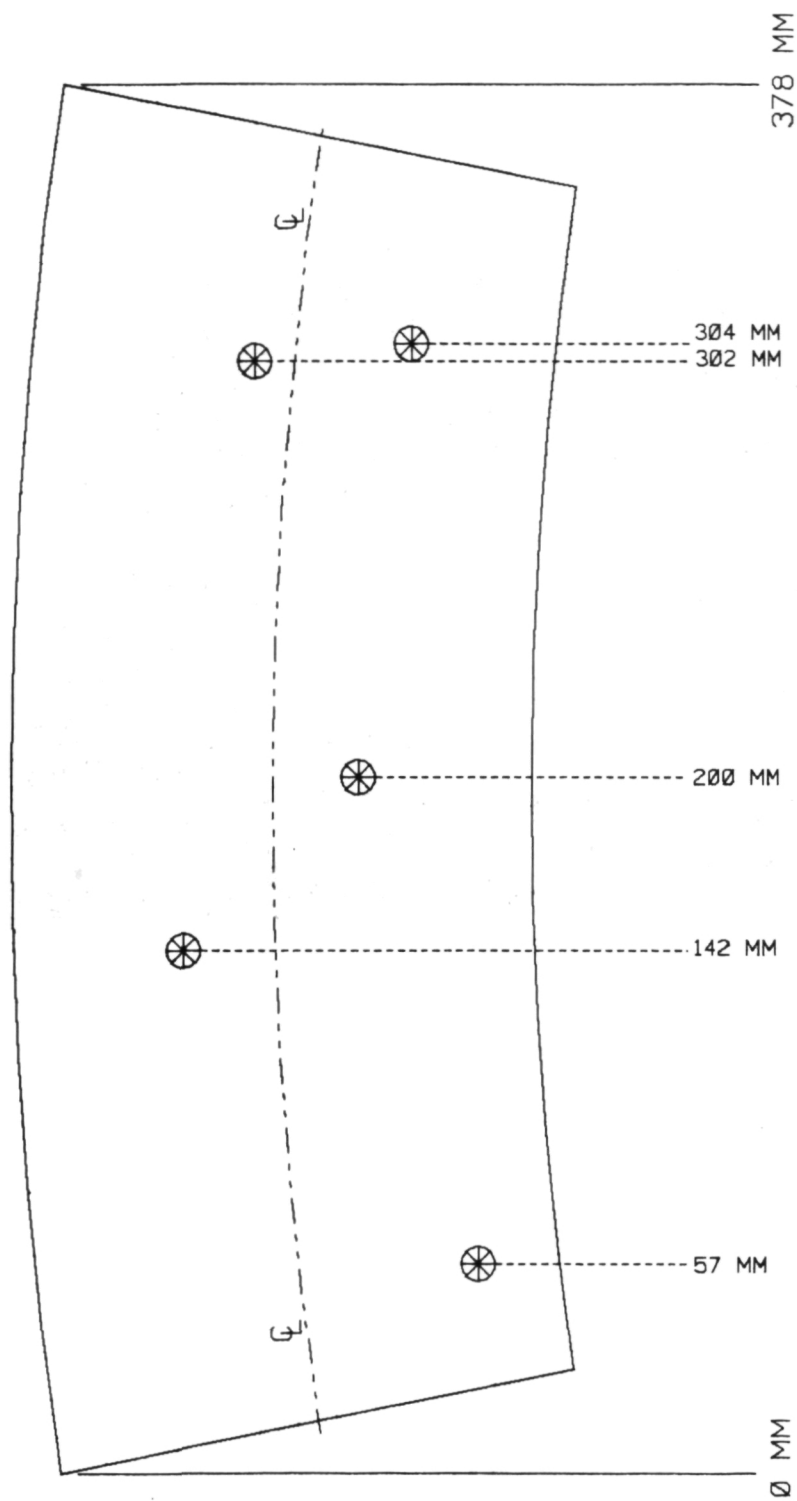
Figure 29. SRM survey sketch. (Location guide for CT of SRM samples.)

Radiographs of each of the unfired segments were mapped to determine correlations with CT data. Detailed surview sketches, identifying the precise location of desired CT slices served as a guide for the tangential direction CT inspection (Fig. 29). In all the segments, several uniform low-density/high-density bands, parallel to the ply lay-up direction were noted (Fig. 30). The density variation present in these bands ranged from 10 to 20 percent (low density, 1.2 g/cc; high density, 1.5 g/cc). These bands may result from the compaction and resin flow procedures present during the cure cycle.

COMMENTS: ⊗ DENOTES ANOMALY TO BE FURTHER INVESTIGATED
ALL DIMENSIONS GIVEN IN MM
DIMENSIONS SHOWN ARE OF PROJECTED SIZE
